Rail Industry Safety Notice

RISN No. 25

PLASSER 09-16 DUAL CAB CONTINUOUS ACTION TAMPER – BRAKING SYSTEM FAILURE

SUBJECT	Plasser 09-16 Dual Cab Continuous Action Tamper - Braking System Failure
----------------	---

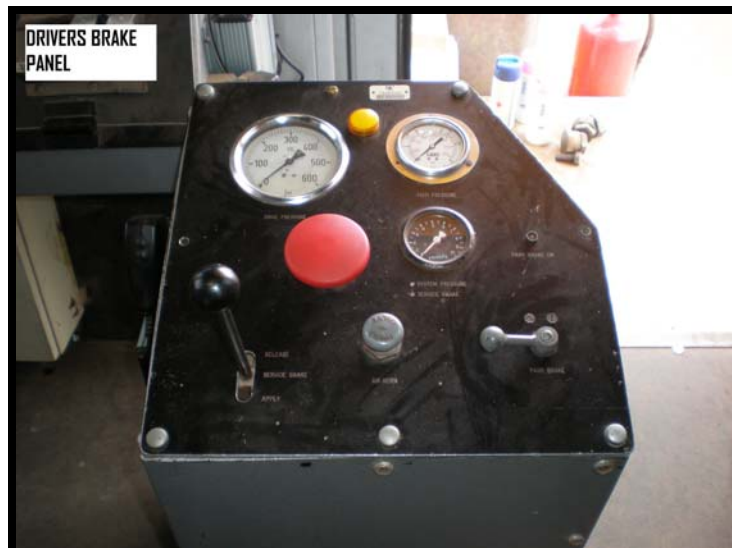
A report has been received by the Office of Rail Safety (WA) relating to the loss of the service brake operation on a Plasser 09-16 Dual Cab Continuous Action Tamper due to the brake lever in the rear cab being knocked into the release position by loose luggage which was stowed in the unattended cab.

1. The Drivers Brake Panel showing the potential for the brake lever to be knocked into the "release" position.

Accredited Rail Transport Organisations either using the Plasser 09-16 Dual Cab Continuous Action Tamper machines or engaging service providers who use these track machines need to be aware of the potential for the service brake lever to be knocked into the “release” position. The issue of instructions to their staff or service providers that loose luggage must not be stowed in a manner that would allow movement or the potential to strike the brake lever in the non-driving end cab when not attended is recommended. Alternatively an engineering solution to minimise the risk of the brake lever being able to be accidentally moved into the release position from the non-driving end needs to be considered by affected parties.

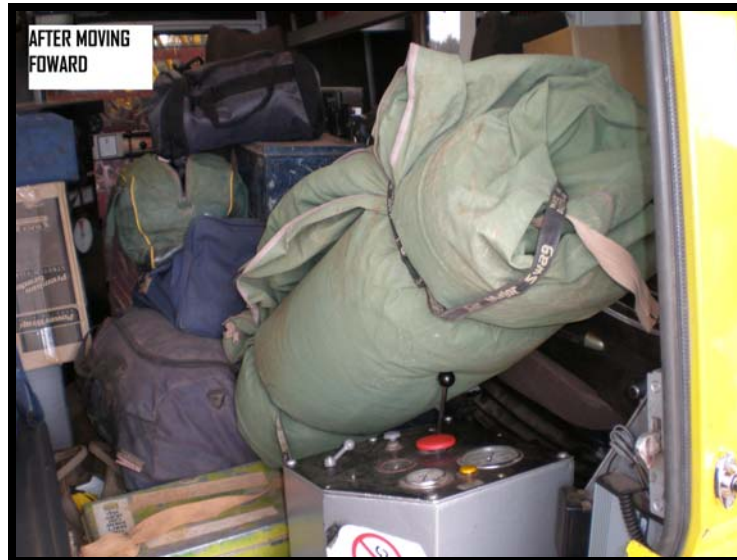
2. The loose luggage movement onto the brake lever forcing it into the “release” position and preventing further brake applications from the other cab.
